Delaware Annual Beach Change Report: Ocean Coast

Delaware Department of Natural
Resources and Environmental Control

Division of Watershed Stewardship
Shoreline and Waterway Management
285 Beiser Blvd., Suite 102
Dover, DE 19904
302-739-9921

October 2023

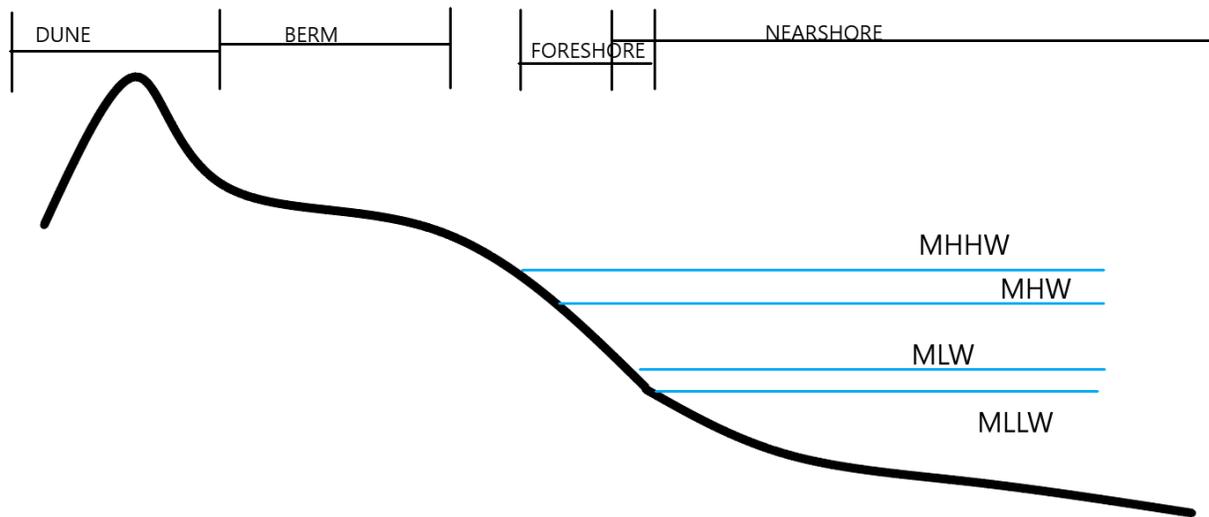
Figure 1: Beach profile definitions sketch

Dune – Natural or man-made geological feature that is shoreward of the berm and is characterized by a steep slope to the highest elevations along the beach profile.

Berm – The relatively flat portion of the beach profile directly seaward of the dune that is typically above the MHHW elevation.

Foreshore Slope – The foreshore slope is the natural slope directly seaward of the berm that is caused by tides and up rushing waves.

Intertidal Zone – The portion of the foreshore slope and nearshore that is between the MHHW and MLLW elevations.

Nearshore – For the purposes of this report, the nearshore is considered to extend from the lower portions of the intertidal zone out beyond the surf zone where waves break but onshore of most boating traffic.

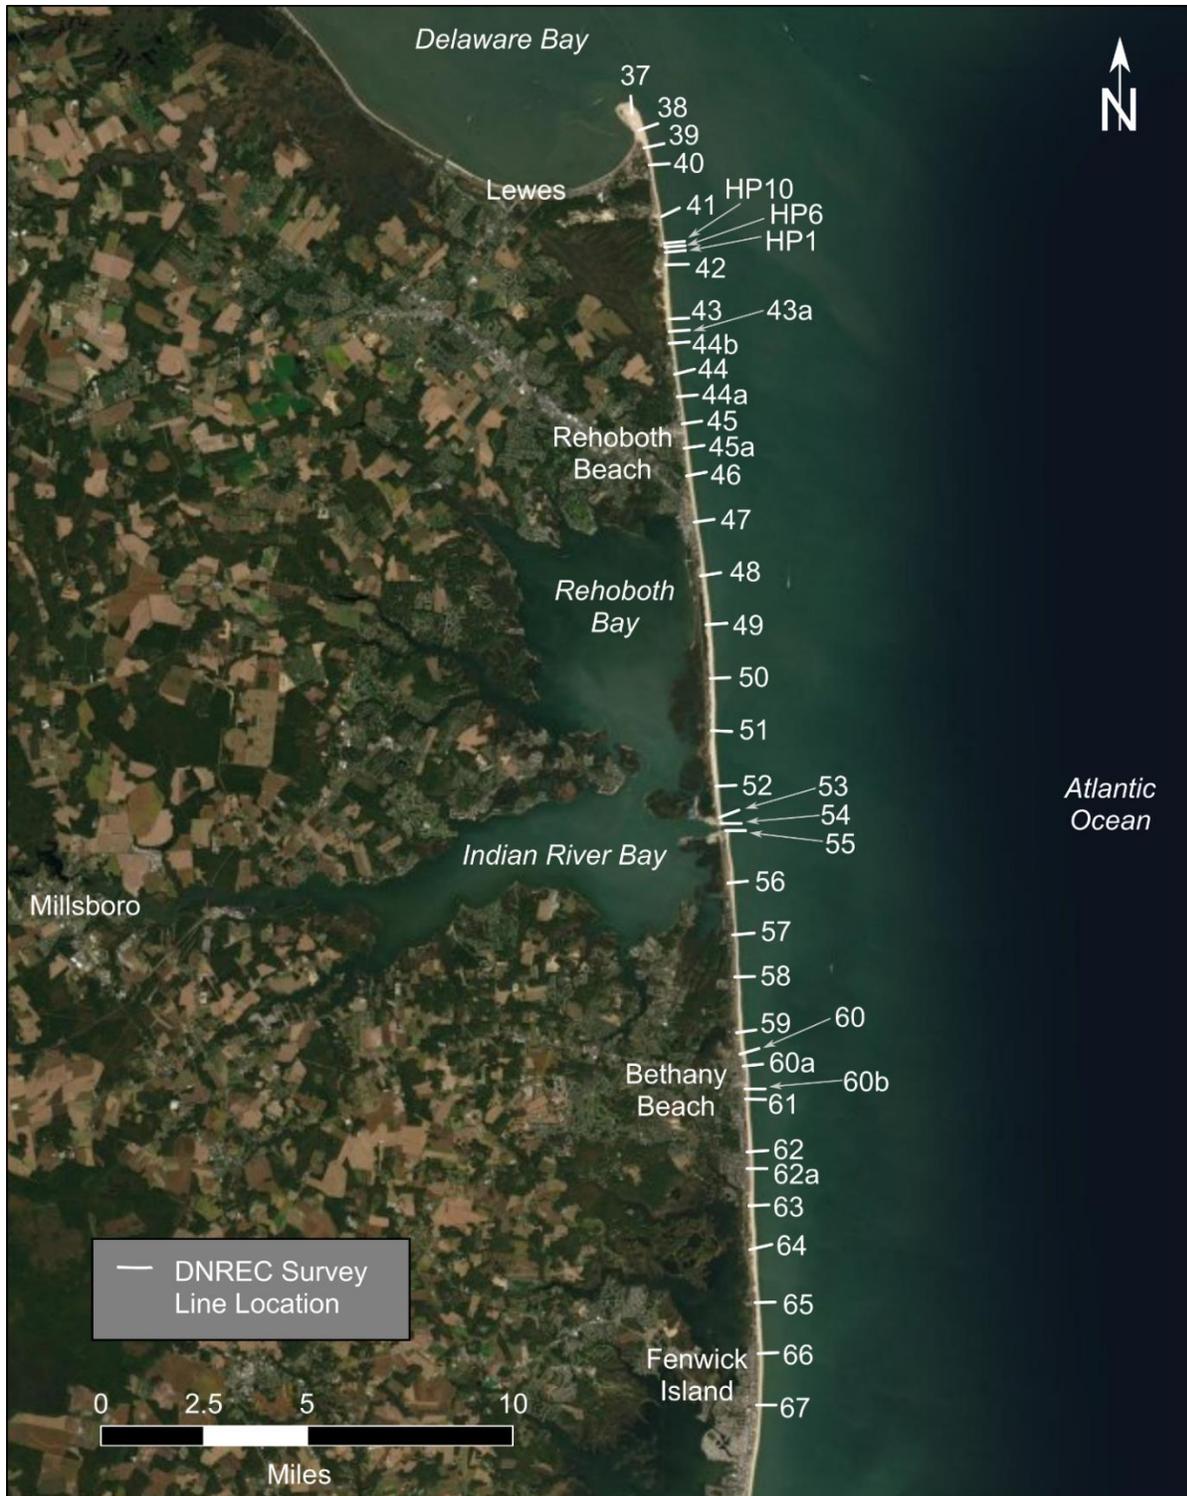
Figure 2: LRP location map

Each fall and spring, the Section’s survey crew measures the beach (berm, dune, and nearshore bathymetry). Bathymetry data are collected out to about a 30-foot depth. The crew measures 41 longitudinal range profiles (LRPs) or transects along the Atlantic Coast. These locations of these transects are shown in Figure 2. Comparisons between winter and summer surveys demonstrate how beaches recover naturally after winter storms. Comparison between summer surveys from year-to-year, demonstrate long term erosion or accretion trends along Delaware Beaches. These trends are used to inform beach management strategies including beach nourishment projects.

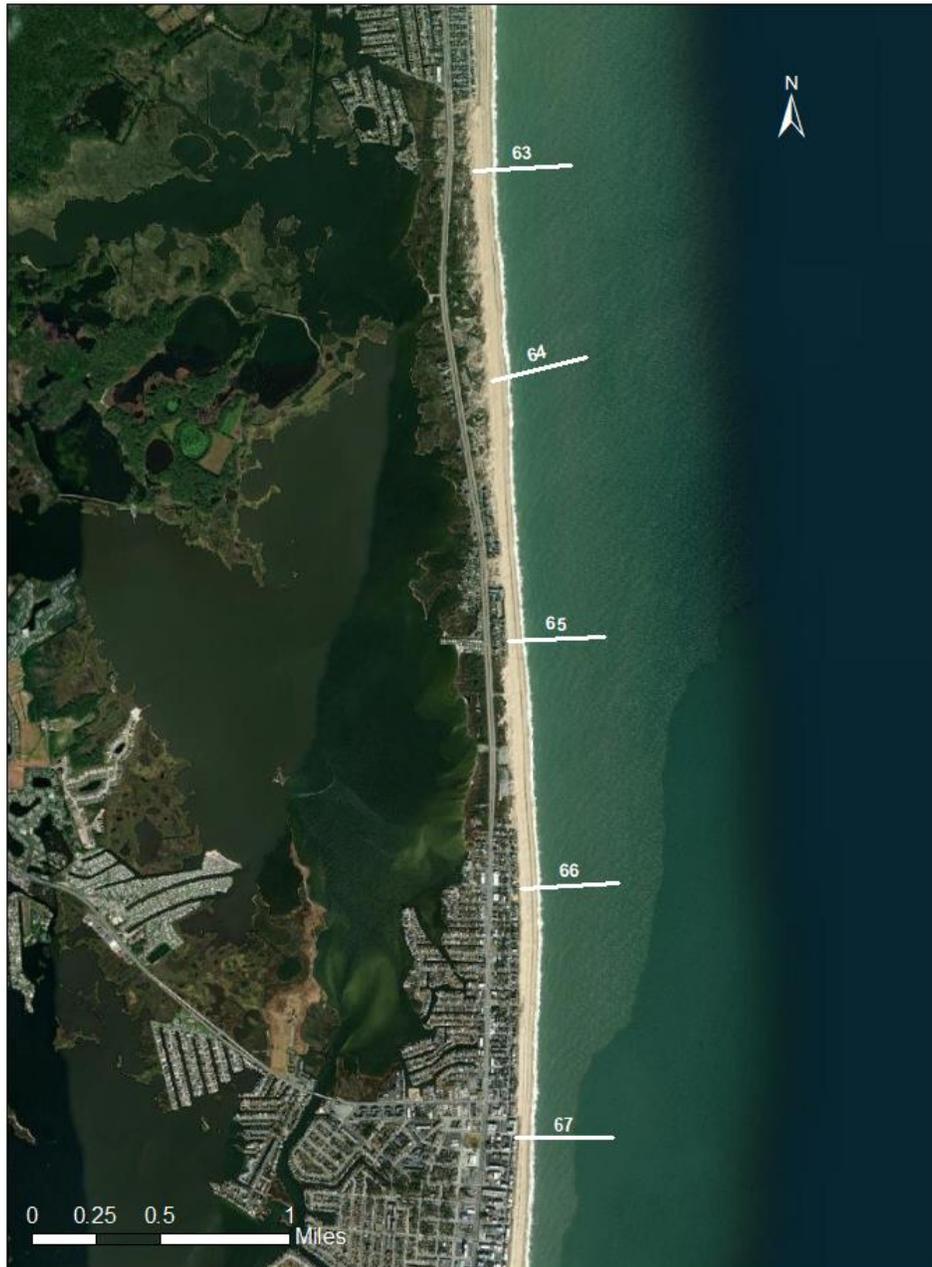
Figure 4: LRP location map for Fenwick Island

Fenwick Island is densely populated from the Delaware and Maryland state line to about 1 mile north of this boundary. North from this location, the coastline is sparsely populated and includes Fenwick Island State Park. There are five survey lines spaced roughly 5,000' feet apart along the section of coastline as shown in Figure 5. Within Fenwick Island, there is a federal nourishment project that aims to protect the developed portion of the shoreline.

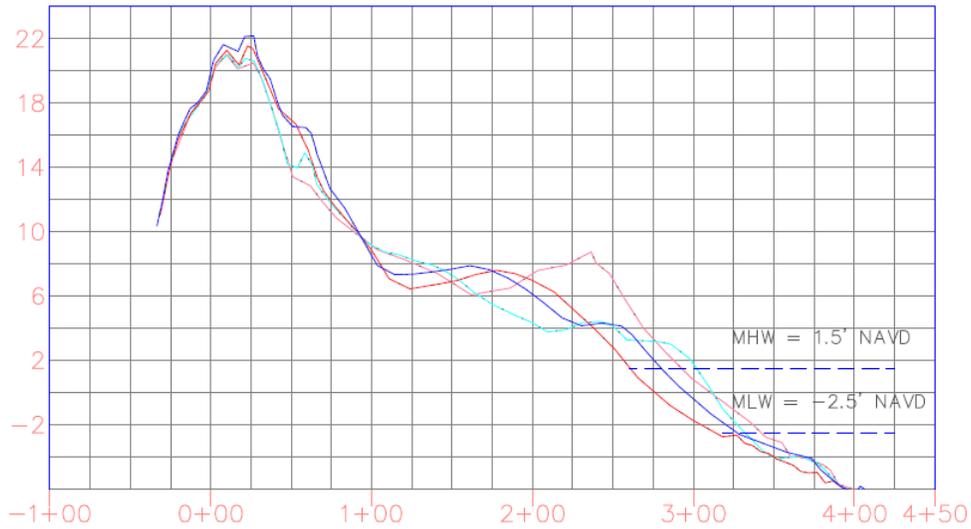
Figure 5: Representative profile in Fenwick Island. The plots are as follows: Summer 2021 (pink); Summer 2022 (red); Winter 2022 (cyan); Winter 2023 (blue). The dashed blue lines represent the tide levels with the higher line being MHW and the lower line being MLW.

A representative seasonal profile view for Fenwick Island is shown in Figure 6. For each beach, one profile view is shown in the body of the report with the remaining plots residing in Appendix B. In Summer of 2021, the berm was 2-4' higher in elevation near the shoreline but lower in elevation closer to the dune. This accounts for the larger volume above MHW in Summer of 2021. This volume of sand appeared to be pushed landward and reshaped in subsequent seasons. The dune appears to have grown in elevation which is expected since wind blown sand is trapped by dune vegetation and the dune as not been eroded by surge and wave action.

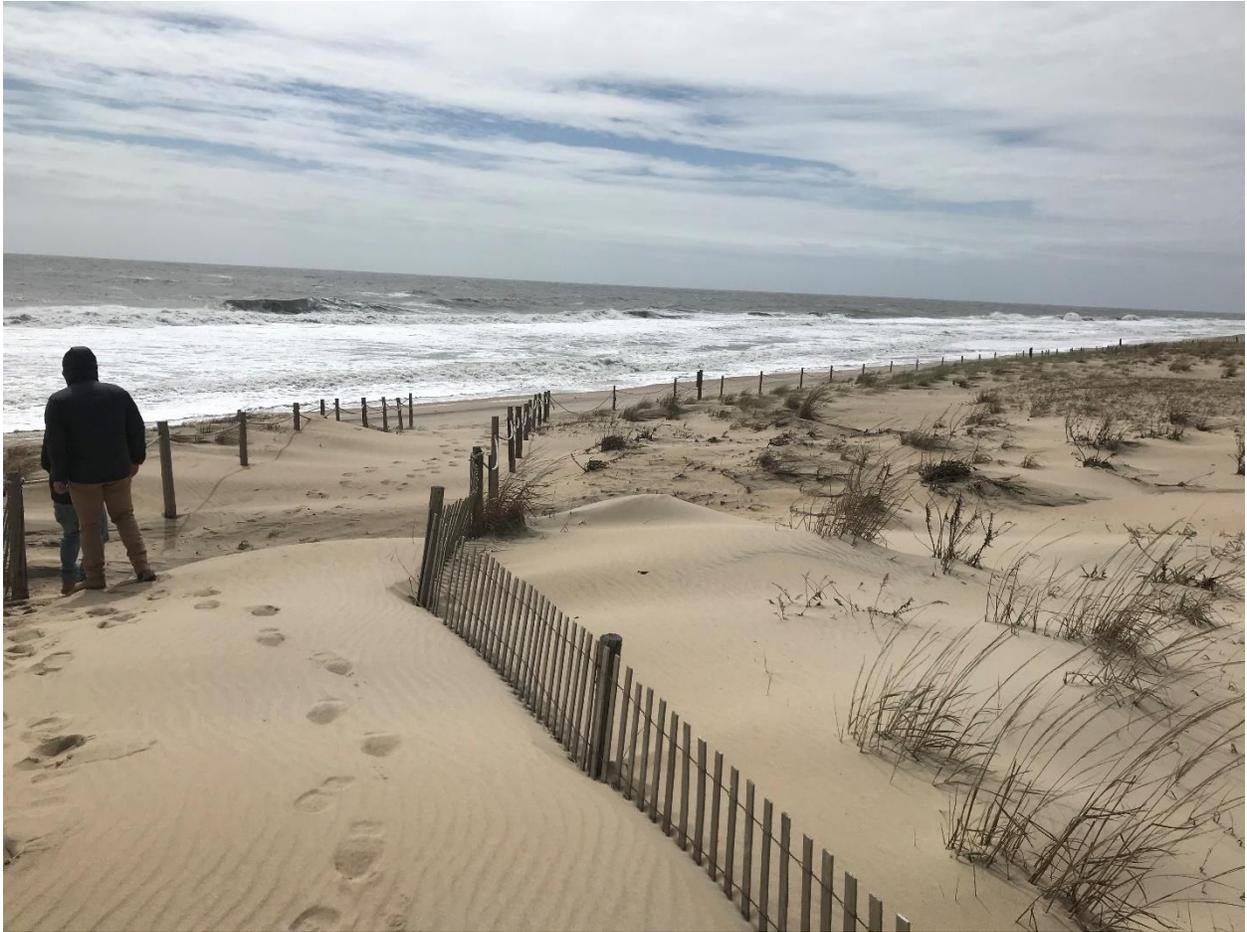
Figure 6: Photo of Fenwick Island taken from the dune on May 5th, 2022 during the "2022 Mother's Day Storm"

The Section's crew responded one of the storm surge events that impacted Fenwick Island on 05/09/2022. Fenwick Island is nourished by the USACE in partnership with DNREC. Fenwick Island is also directly adjacent to Ocean City, Maryland which is also nourished by the USACE. Therefore, Fenwick Island tends to be sediment rich. During this storm, the surge and wave action reached the toe of the dune. A vast amount of wind blown sand was accumulated on the dunes and in the crossovers as seen in Figure 6 below.

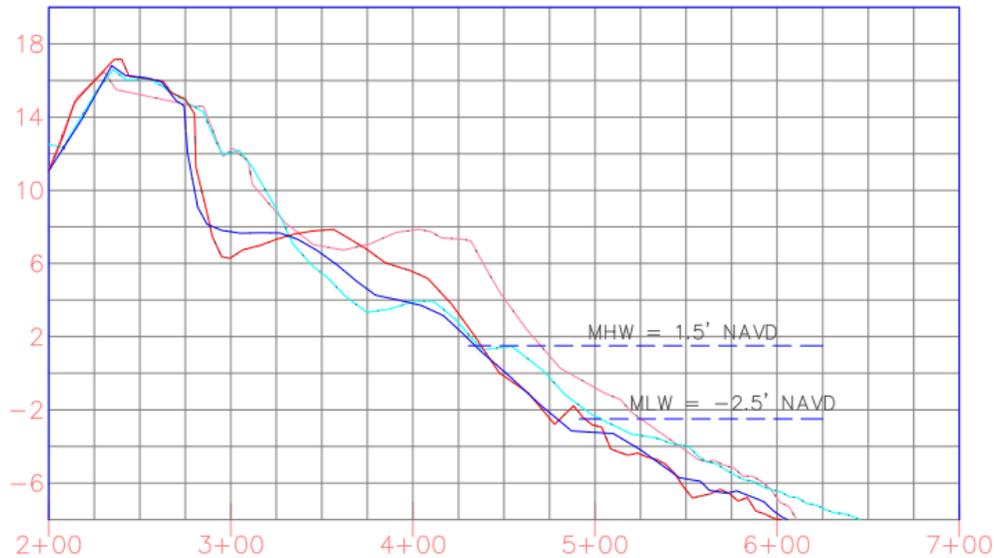
Figure 8: Representative Profile in South Bethany: The plots are as follows: Summer 2021 (pink); Summer 2022 (red); Winter 2022 (cyan); Winter 2023 (blue). The dashed blue lines represent the tide levels with the higher line being MHW and the lower line being MLW.

Similar to the example profile from Fenwick Island, LRP 62 in South Bethany has a large volume of sand near the shoreline in Summer 2021 which has been pushed inland and reshaped in the foreshore over the subsequent seasons. The storm damage to the dune that occurred on 05/09/2022, preceding the Summer 2022, is evident in the profile comparison. The dune eroded back about 35-40' leaving a 7' scarp.

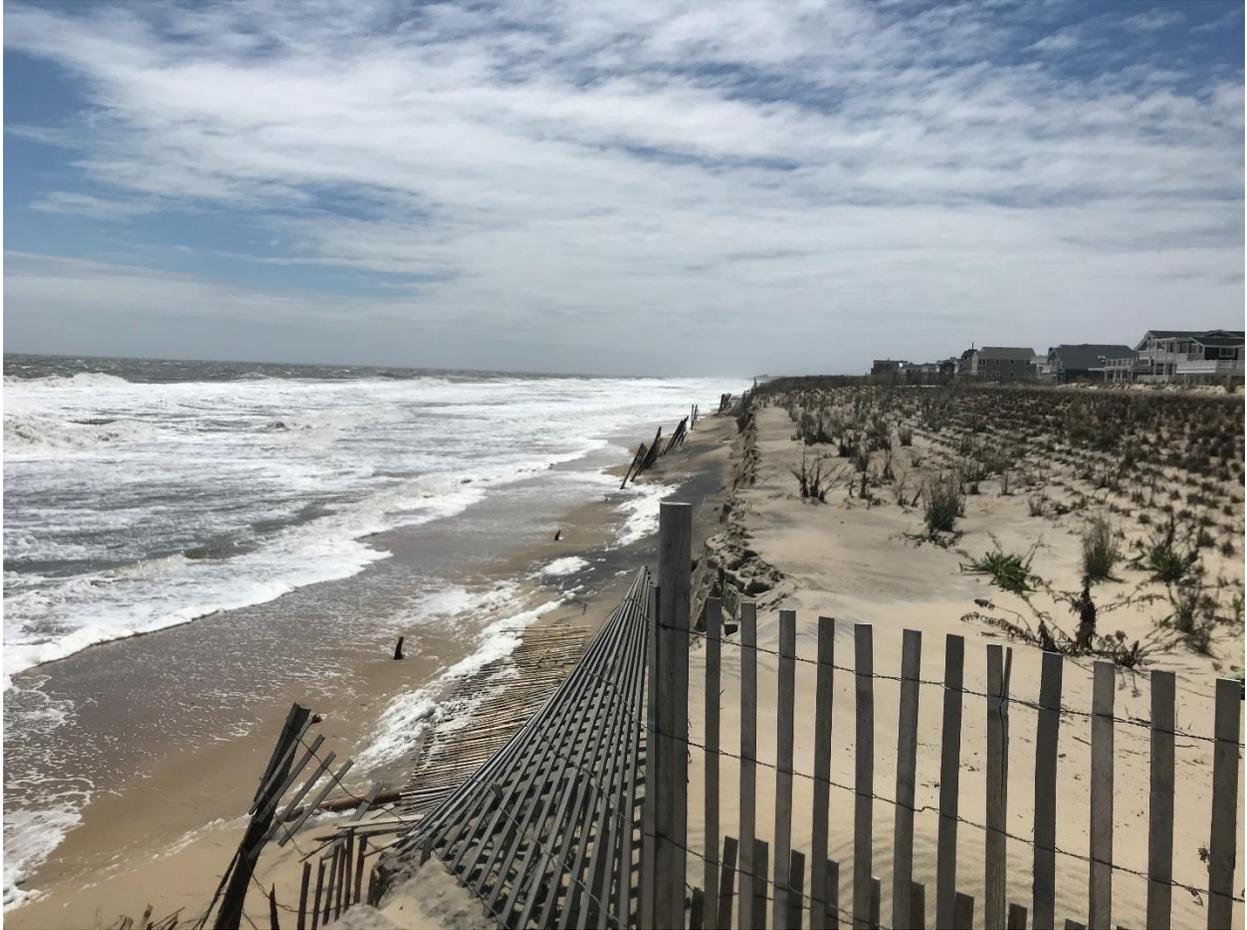
Figure 9: Storm tide and wave erosion during the Mother's Day storm in 2022.

The Section's crew responded one of the storm surge events that impacted South Bethany on 05/09/2022. During this storm, the surge and wave action the dune causing severe erosion and scarping of the dune. The scarping of the dune left the beach nearly inaccessible from the pedestrian dune crossing. The dune erosion depicted in Figure 8 is also detectable in Figure 9 based on the position of the fence line relative to the eroded dune position.

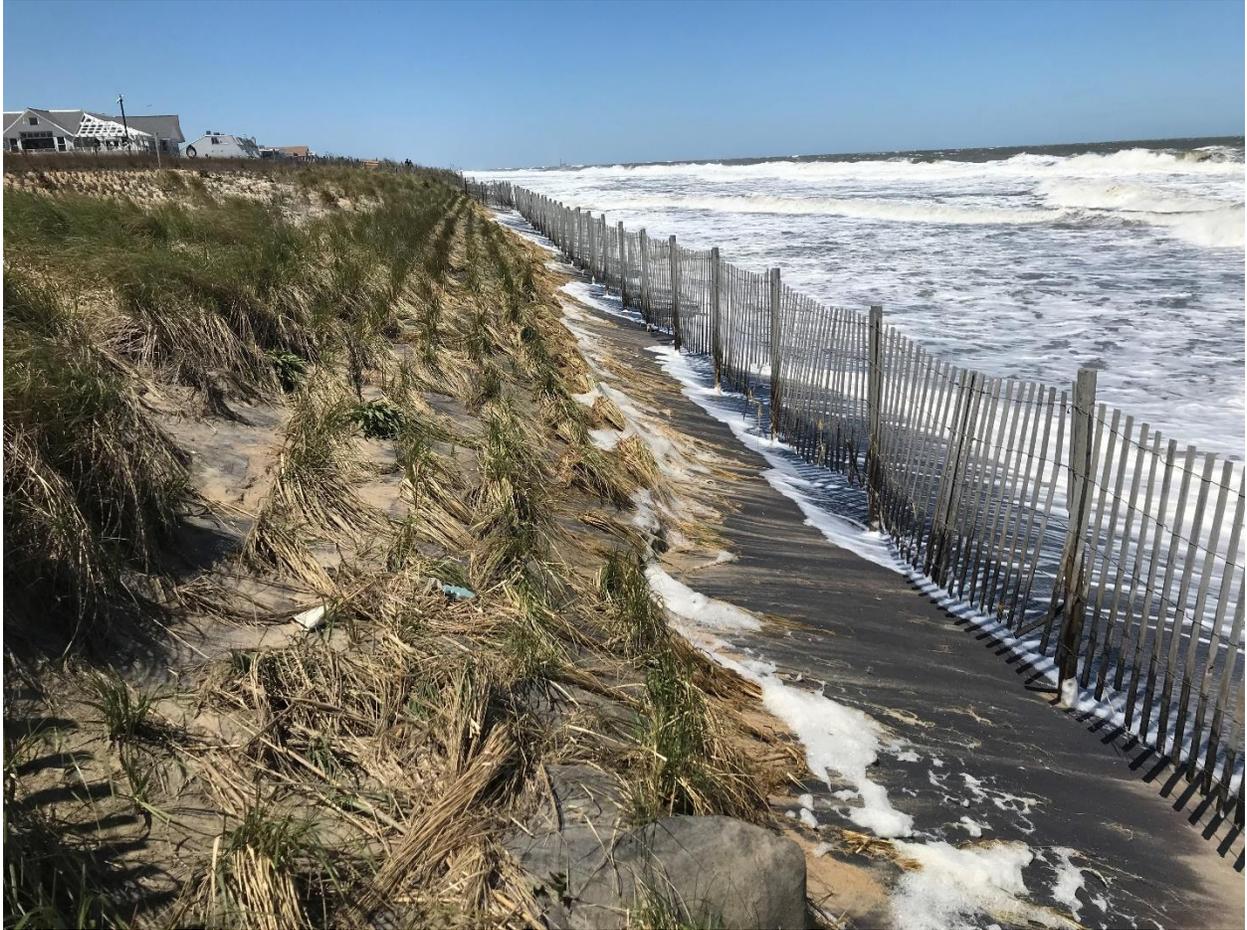
Figure 12: Storm tide and wave conditions in Bethany Beach during the Mother's Day Storm of 2022

The Section's crew responded one of the storm surge events that impacted Bethany on 05/09/2022. During this storm, the surge and wave action the dune causing some erosion and scarping of the dune. The scarping of the dune left moderately scarped. The beach access was moderately impacted in some sections of the coast.

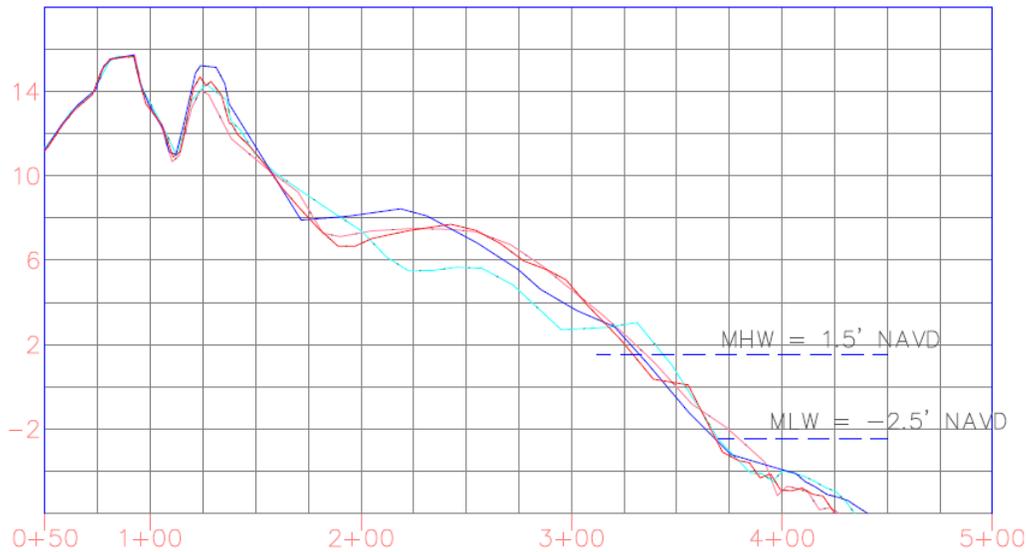
Figure 14: Oceanview: The plots are as follows: Summer 2021 (pink); Summer 2022 (red); Winter 2022 (cyan); Winter 2023 (blue). The dashed blue lines represent the tide levels with the higher line being MHW and the lower line being MLW.

The beach profiles in Oceanview are shown in Figure 14. The substantial erosion from Summer 2021 to Winter 2022 is evident. The subsequent recover of the profile and much less substantial erosion in Winter 2023 is also observable.

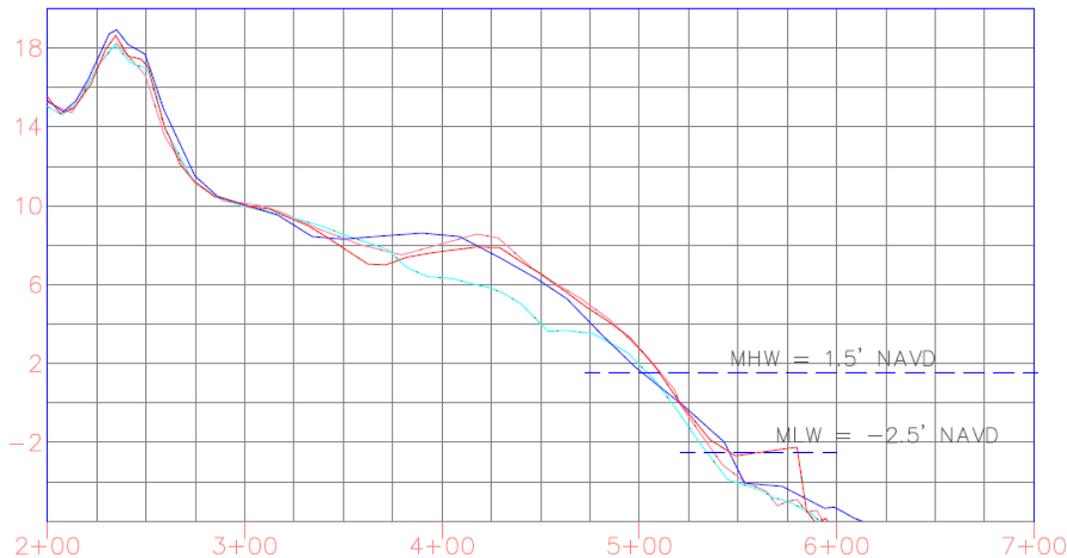
Figure 16: DSSP South: The plots are as follows: Summer 2021 (pink); Summer 2022 (red); Winter 2022 (cyan); Winter 2023 (blue). The dashed blue lines represent the tide levels with the higher line being MHW and the lower line being MLW.

The profile comparison shown in Figure 16 shows that the berm eroded substantially between Summer 2021 and Winter 2022. The beach recovered prior to the Summer 2022 survey and experience little change observable in the Winter 2023 profile.

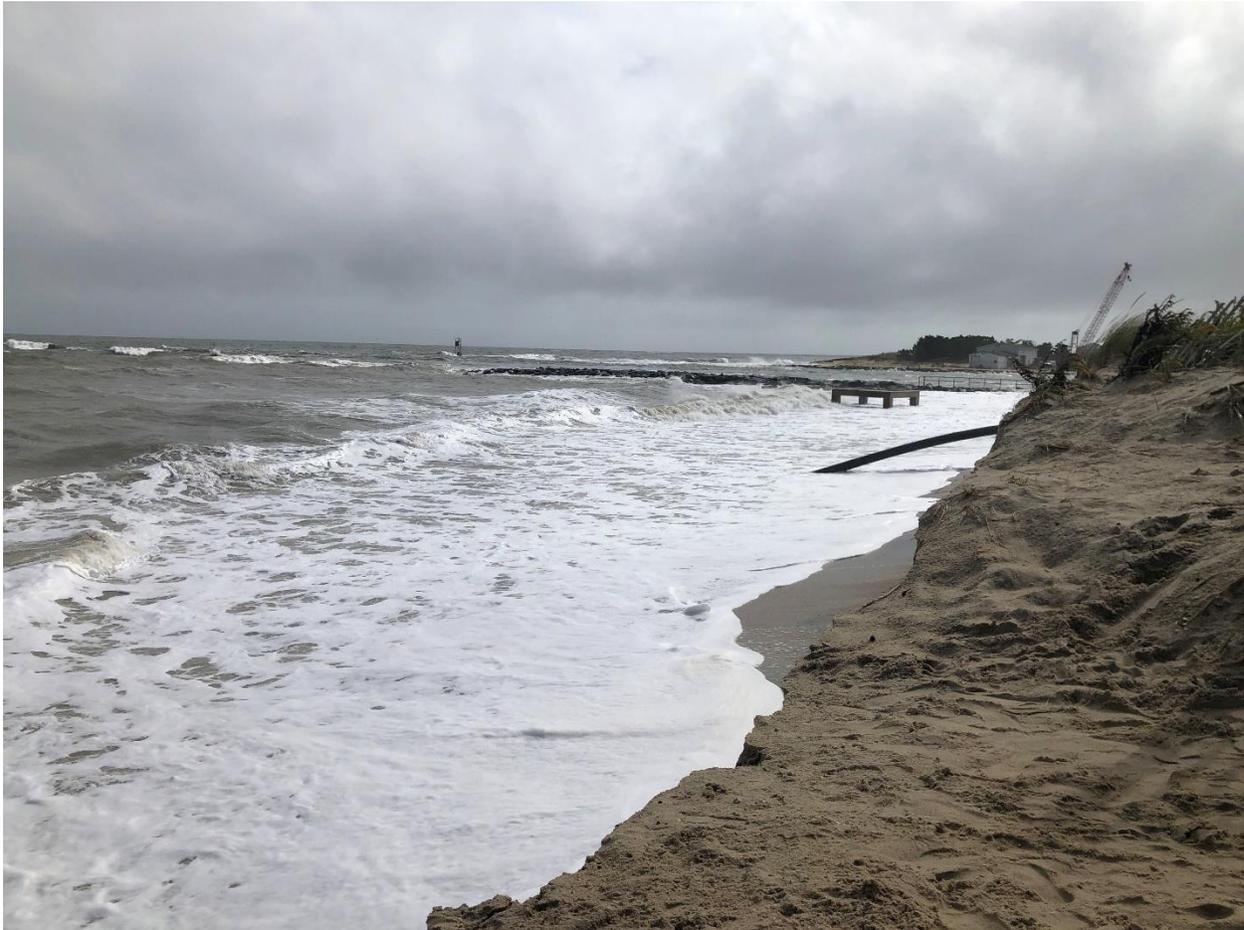
Figure 20: Storm surge and waves at Northside Indian River Inlet on 10/10/2021

On 10/10/2021 the section observed the beach during a coastal storm. The storm cause extensive dune and beach erosion. The picture in Figure 20, shows elevated water level, wave setup, and uprush at Northside Indian River Inlet beach.

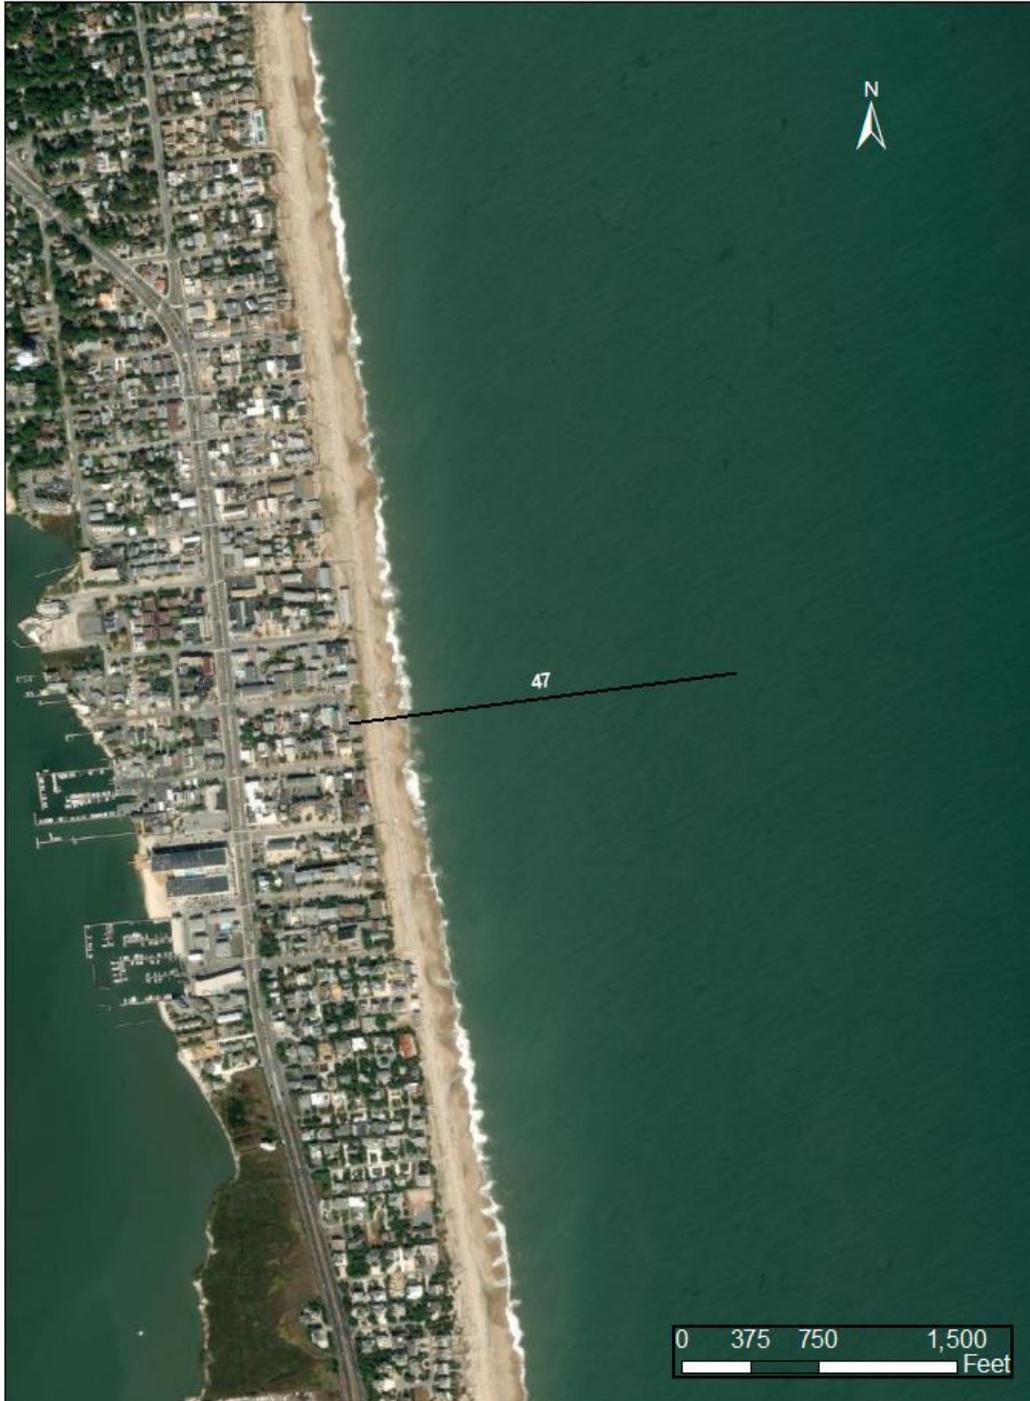
Figure 21: LRP location in Dewey Beach

North of Indian River, Dewey Beach extends roughly 7,500' northward to Silver Lake Shores, which separates Dewey and Rehoboth Beaches. Dewey is densely populated and consists of only one survey line located near the southern town limit. Silver Lake Shores also includes one survey line as shown in Figure 21.

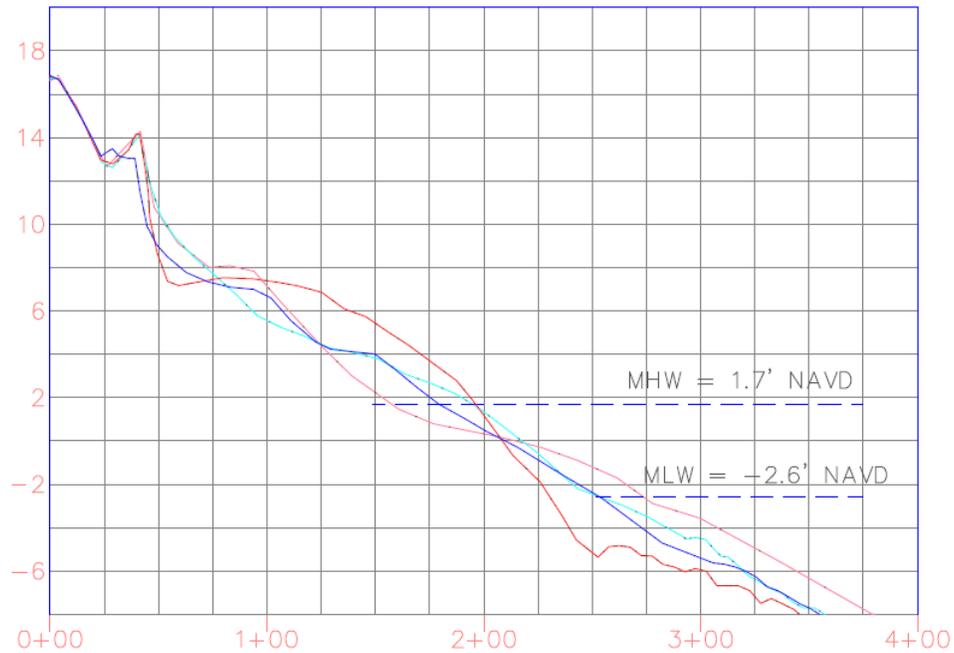
Figure 22: Dewey Beach: The plots are as follows: Summer 2021 (pink); Summer 2022 (red); Winter 2022 (cyan); Winter 2023 (blue). The dashed blue lines represent the tide levels with the higher line being MHW and the lower line being MLW.

Between Summer 2021 and 2022, the volume of Dewey Beach increased but lost all the gains from Summer 2022 to Winter 2023. It is unexpected that the beach volume grew between Winter and Summer 2022 owing to the Mother’s Day storm that appeared to cause substantial erosion. It is possible that the beach did, in fact, experience extensive erosion and the eroded material wash back up the beach during the calm summer conditions.

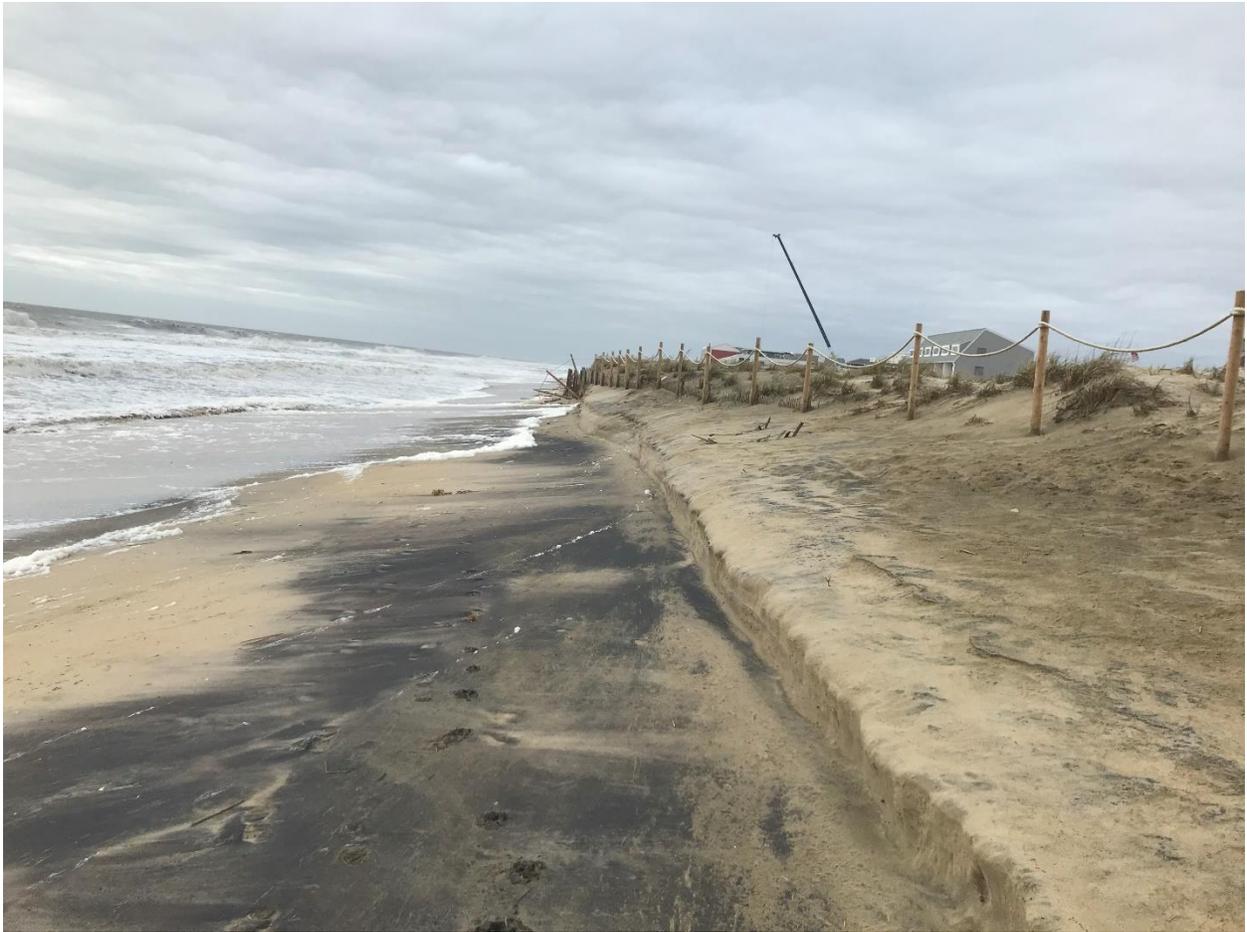
The Section's crew responded one of the storm surge events that impacted Dewey on 05/09/2022. During this storm, the surge and wave action the dune causing some erosion and scarping of the dune. The scarping of the dune left moderately scarping in southern part of the beach. Beach access was not impacted. In the center and northern part of the beach, the storm tide barely reached or stopped short of the dune.

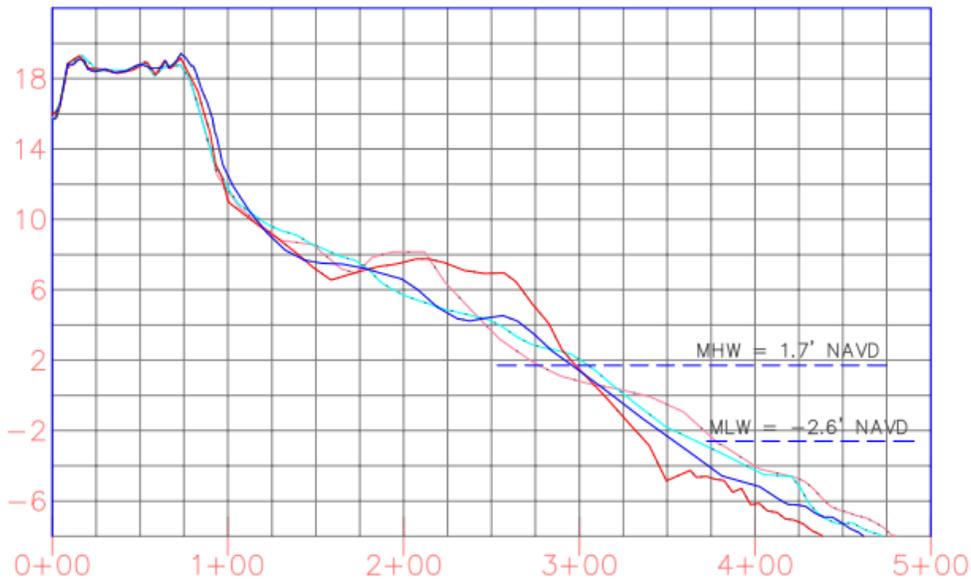
Figure 24: Rehoboth Beach: The plots are as follows: Summer 2021 (pink); Summer 2022 (red); Winter 2022 (cyan); Winter 2023 (blue). The dashed blue lines represent the tide levels with the higher line being MHW and the lower line being MLW.

The seasonal profiles in Rehoboth Beach are shown in Figure 24. The large variability in the beach profile from season to season can be seen. The berm in Summer 2022 was the largest but the foreshore slope is steeper. Also, there is a dip in elevation near the toe of the dune, which is likely the eroded conditions owing to the Mother’s Day Storm.

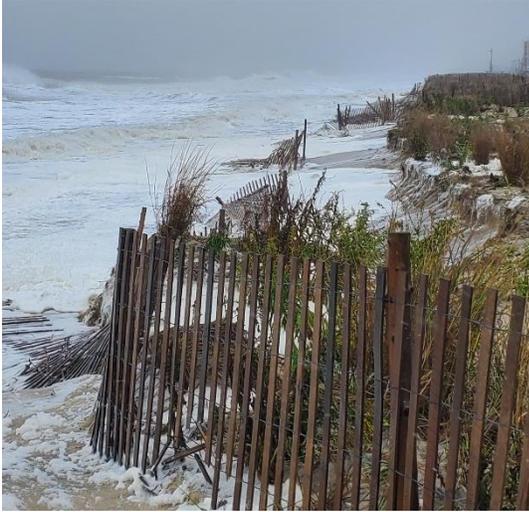
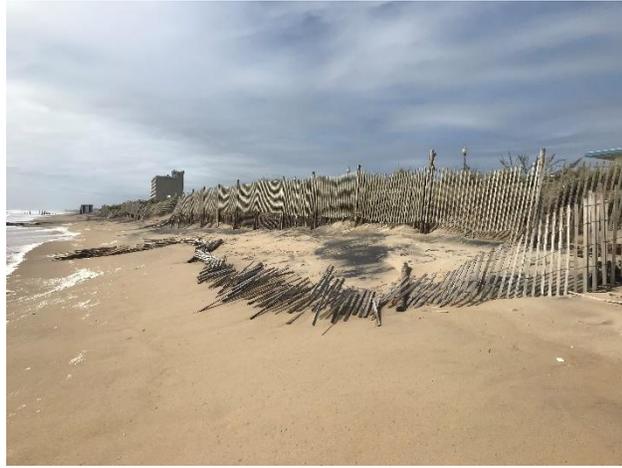
Figure 25: Picture of storm surge and beach damage in Rehoboth Beach during October of 2021 (left) and May of 2022 (right)

The Section's crew responded to three storm events that impacted Rehoboth on October 3rd and 9th of 2022 and 2021, respectively, in addition to the Mother's Day Storm. During this storm, the surge and wave action the dune causing some erosion and scarping of the dune. The scarping of the dune left moderately scarped in southern part of the beach. Beach access was not impacted. In the center and northern part of the beach, the storm tide barely reached or stopped short of the dune.

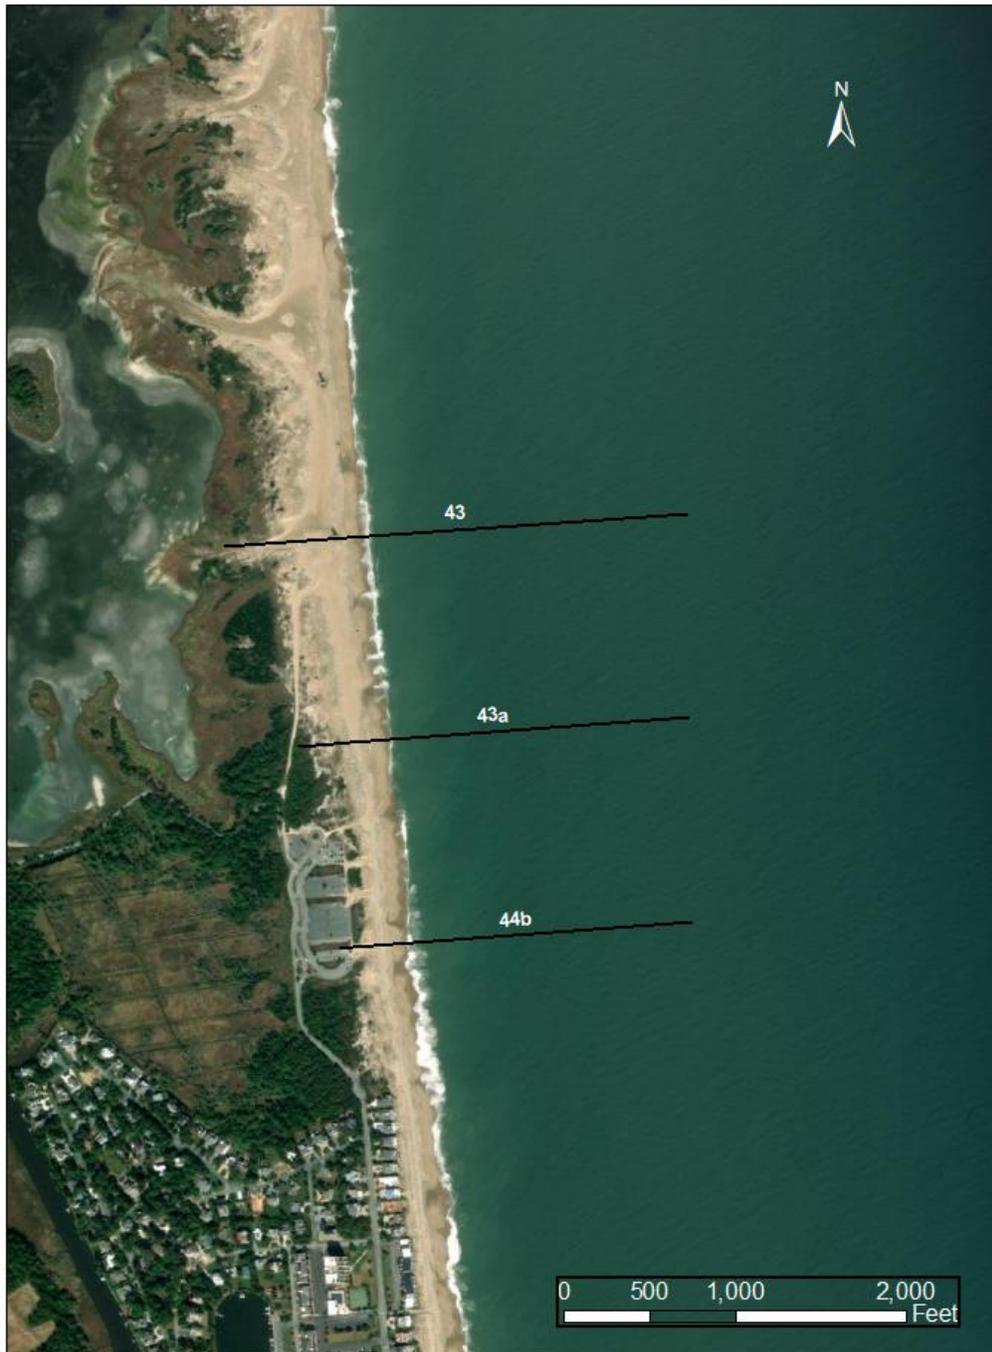
Figure 26: LRP location in Gordon's Pond State Beach

North of Henlopen Acres, which contains one profile line, is North Shores and Gordon Pond State Beach. This section of coast includes three profile lines.

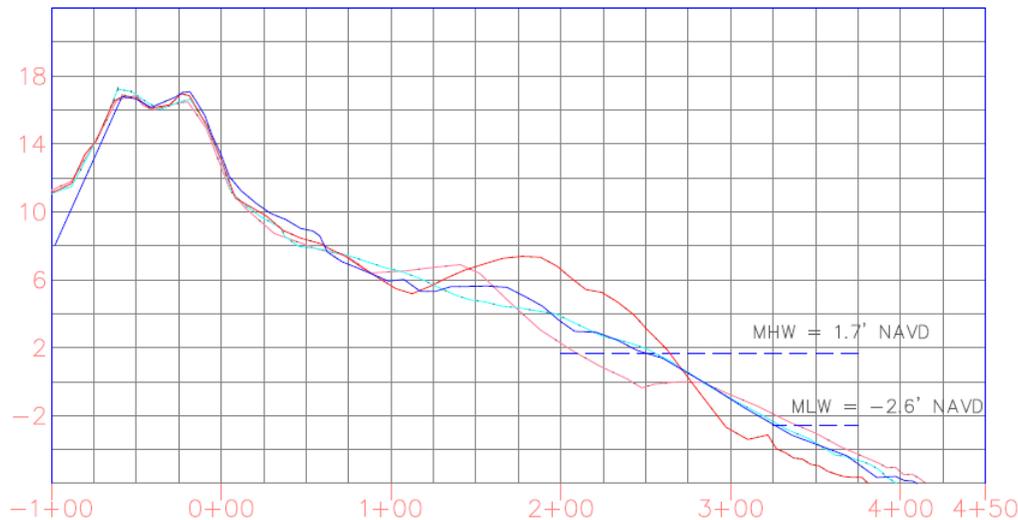
Figure 27: Gordons Pond: The plots are as follows: Summer 2021 (pink); Summer 2022 (red); Winter 2022 (cyan); Winter 2023 (blue). The dashed blue lines represent the tide levels with the higher line being MHW and the lower line being MLW.

The seasonal profiles in Gordons Pond are shown in Figure 27. The large variability in the beach profile from season to season can be seen. The berm in Summer 2022 was the largest but the foreshore slope is steeper.

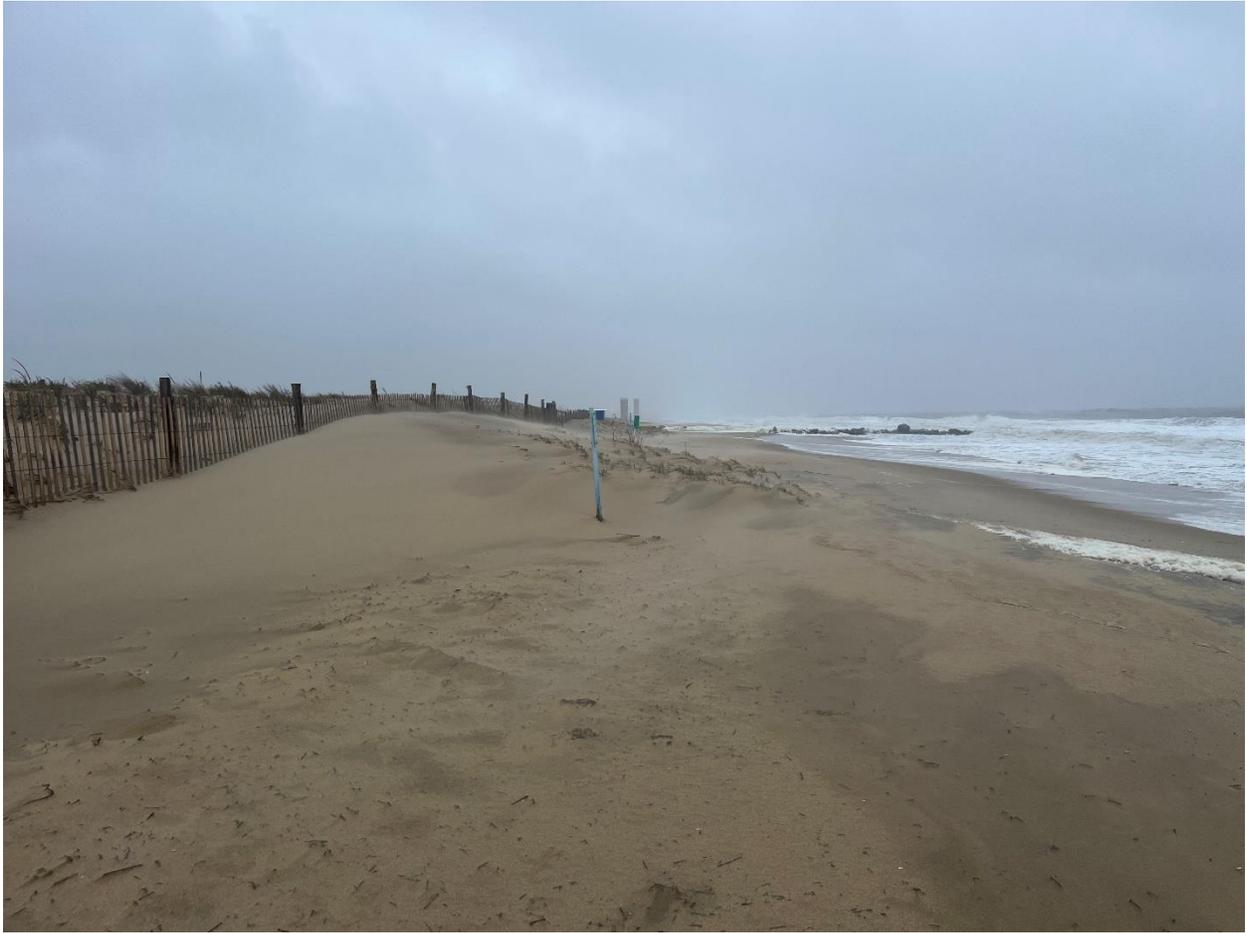
The Section’s crew responded to one of the storm events that impacted Gordons Pond on October 3th of 2022. During the storm, the surge and wave action did not reach the dunes. In fact, the image in Figure 28 demonstrated a foredune growing shoreward of the fence dune limit. This depicts some of the

accretion observed in the reported volumes.

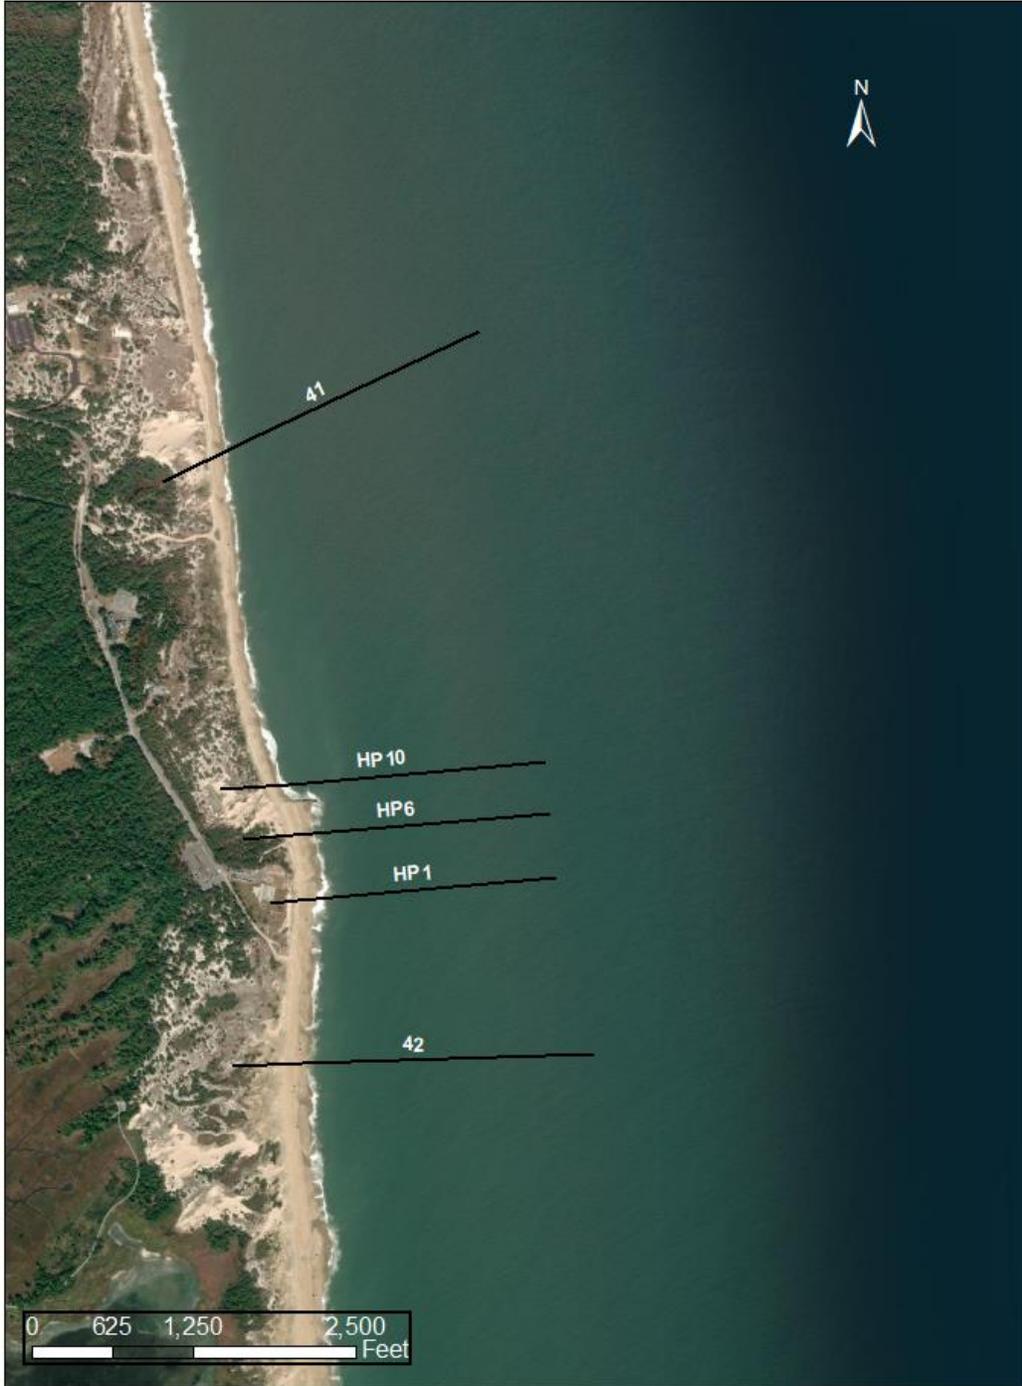
Figure 28: LRP location map in Cape Henlopen State Park at Herring Point

Cape Henlopen State Park is the northernmost section of beach along Delaware’s ocean coast. Herring Point is at the southern end of the park and is characterized by the large naval jetty. There are five LRP lines in Herring Point as shown in Figure 28.

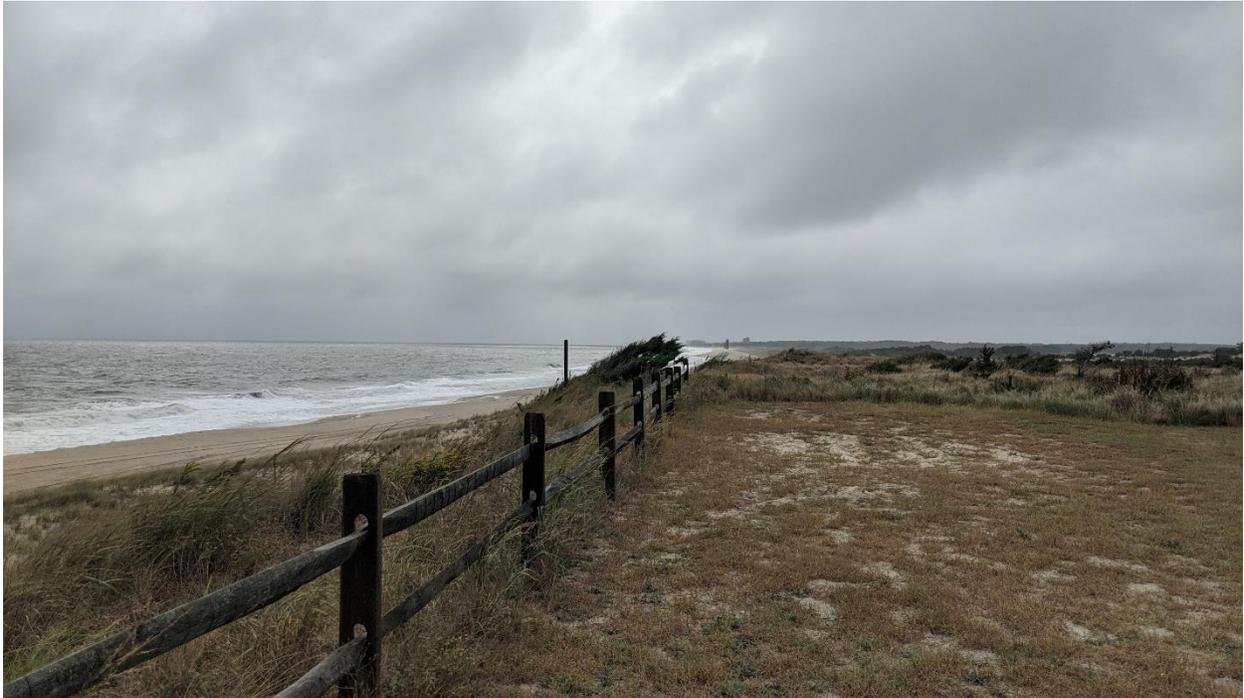
Figure 30: Herring Point during a storm event on 10/12/2021. Winds likely blew sand into the dunes leading to dune growth.

by the vegetation, leading to growth in the dune.
